FOREST PRODUCTS RESEARCH IN PICTURES

NO. 58

CLEANING UP A PULPWOOD STORAGE YARD

FOREST PRODUCTS LABORATORY
U. S. FOREST SERVICE
MADISON, WISCONSIN

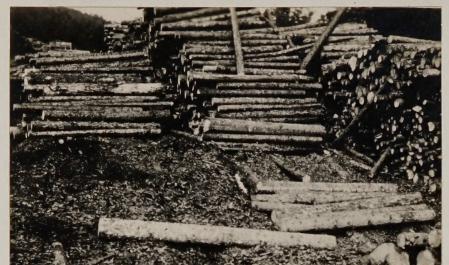
The top picture shows a condition which was once prevalent throughout the yard. Pulpwood was close-piled directly on the ground. No provision was made for air circulation to take up moisture liable to incubate decay, no attempt was made to clean up the decay-favoring litter of bark and rubbish, and no effort was made to insure quick disposal of surface water after rain or spring thaws.

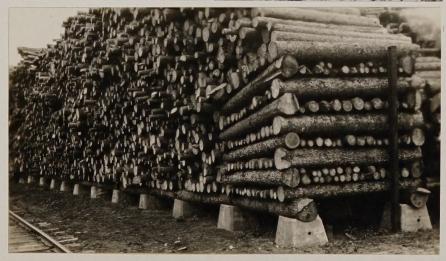
The center photographs show steps in bringing the yard to a sanitary condition - at the left the bark and debris piled for removal and at the right the manner in which the yard was graded to insure proper drainage.
